*TECHNICAL ARTICLE SERIES*

## WRP Conveying Pebble Lime Pneumatically Ends Elbow Failure

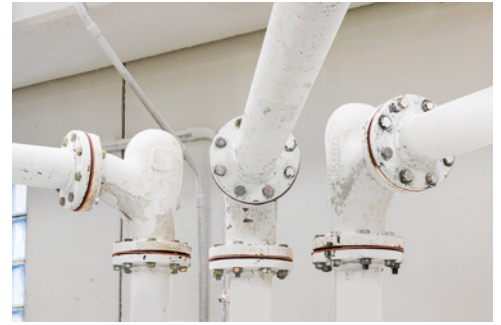
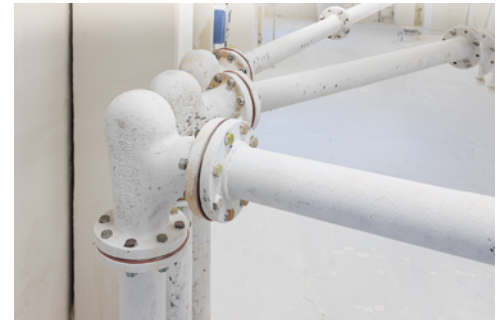
*The Upper Occoquan Water Reclamation plant has gone 16 years without an elbow failure after installing short radius Smart Elbow® deflection elbows.*

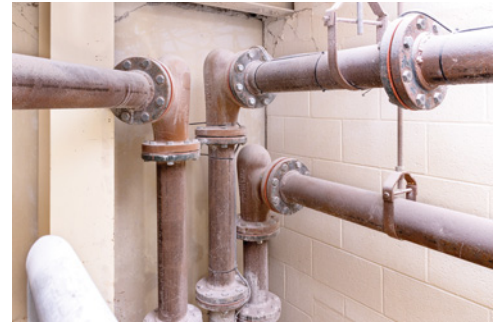
*Installing short-radius deflection elbows put an end to leaks, spills, replacements and associated costs encountered with other type elbows.*

45-degree, four-inch diameter elbows were installed where the trucks off-load their lime and twelve 90-degree, four-inch diameter elbows were installed at the tops of the silos. A custom alloy was specified based on characteristics of the pebble lime and the length and velocity of the pneumatic conveying system.

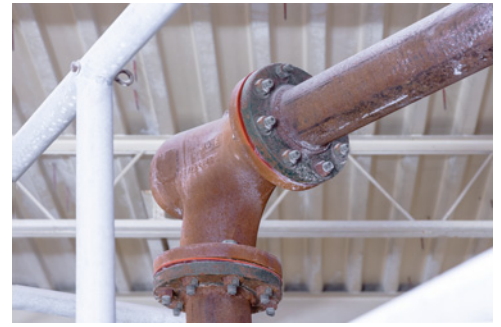
*The Smart Elbow® deflection elbow features a spherical chamber in which incoming particles swirl in a slowly rotating ball, gently deflecting incoming material around the bend without impacting or abrading the elbow wall.*

The elbow is characterized by a spherical chamber that protrudes slightly beyond the desired 90 or 45 degree flow path, causing a loose ball of material to rotate slowly in the same direction as the air stream that powers it, gently deflecting incoming material around the bend. Self-renewing, the ball gradually releases material in a first-in, first-out progression, promoting directional change without affecting system pressure.
